PASSAIC RIVER BASIN

# PACKANACK LAKE DAM

## PHASE I INSPECTION REPORT NATIONAL DAM SAFETY PROGRAM

NJ 00239

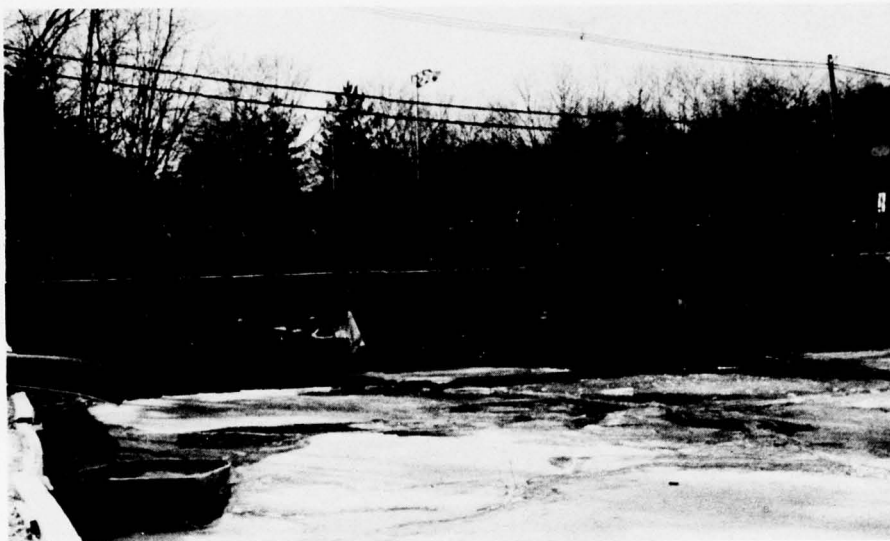
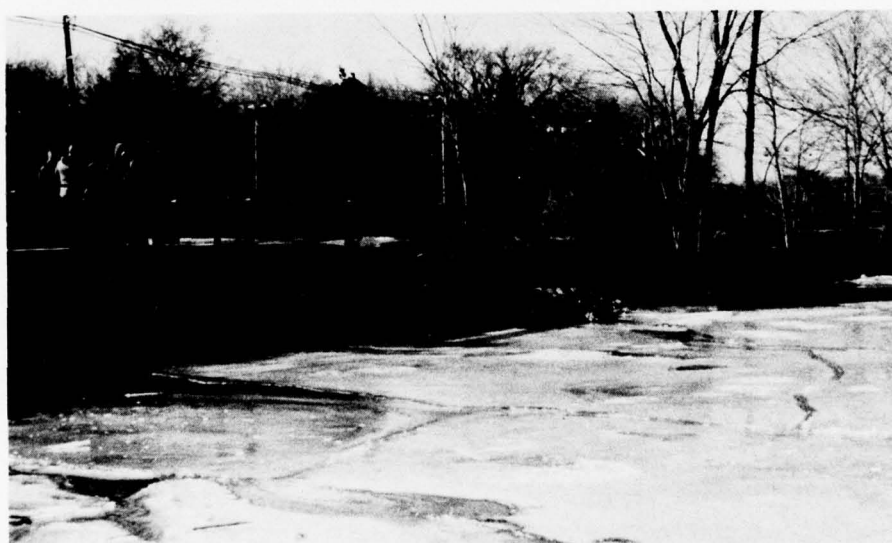
OVERALL VIEW OF DAM, SPILLWAY AND BRIDGE  
OVER SPILLWAY

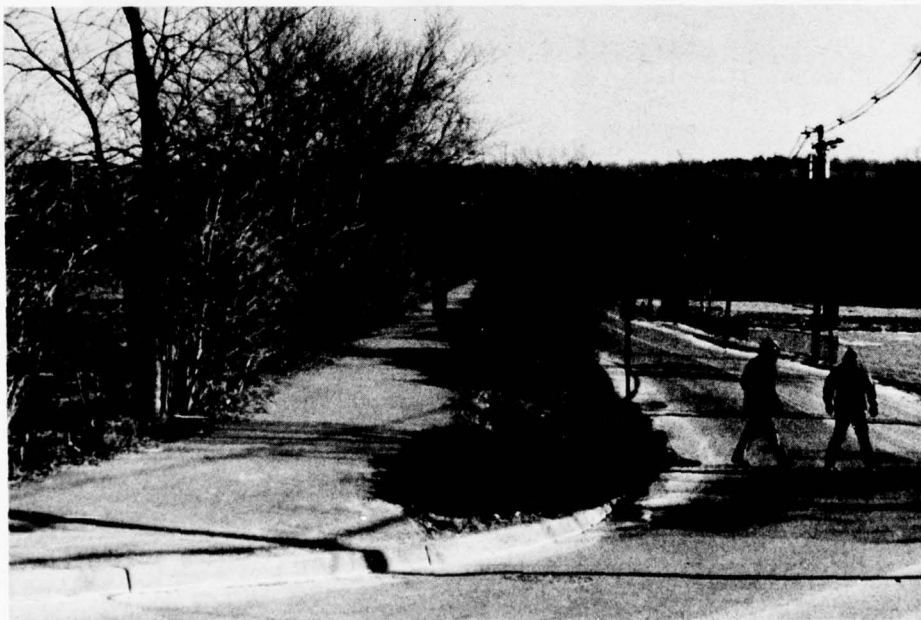
WEST END OF DAM

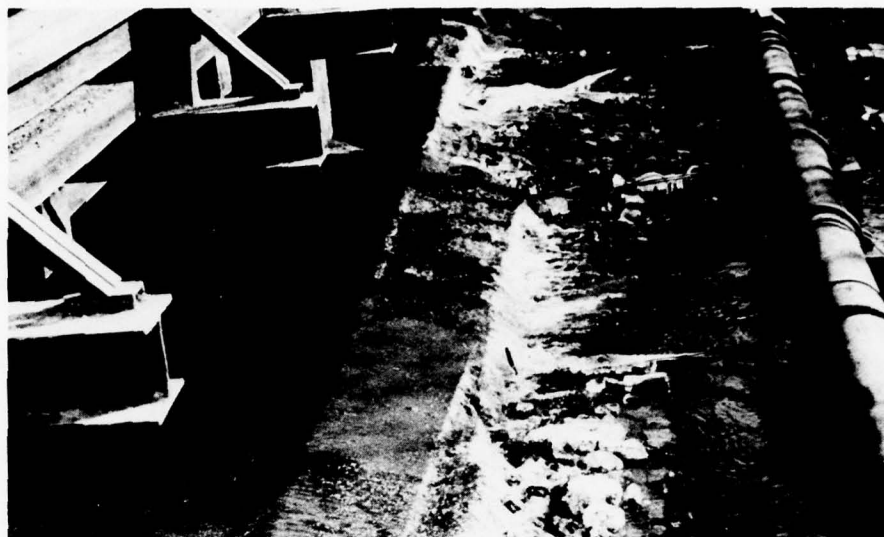
A considerable amount of concrete spalling and deterioration on and around the spillway, as well as cracking of the concrete piers supporting the bridge over the spillway was observed. The downstream end of the spillway has been undermined, and part of the spillway sill is broken away. An 18 inch diameter sanitary sewer line is located in the outlet channel just downstream of the spillway. The sewer line affects the discharge capacity of the spillway, and contributes to the erosion taking place downstream of the spillway by directing the flow toward the stream bed.

DOWNSTREAM END OF SPILLWAY LOOKING EAST

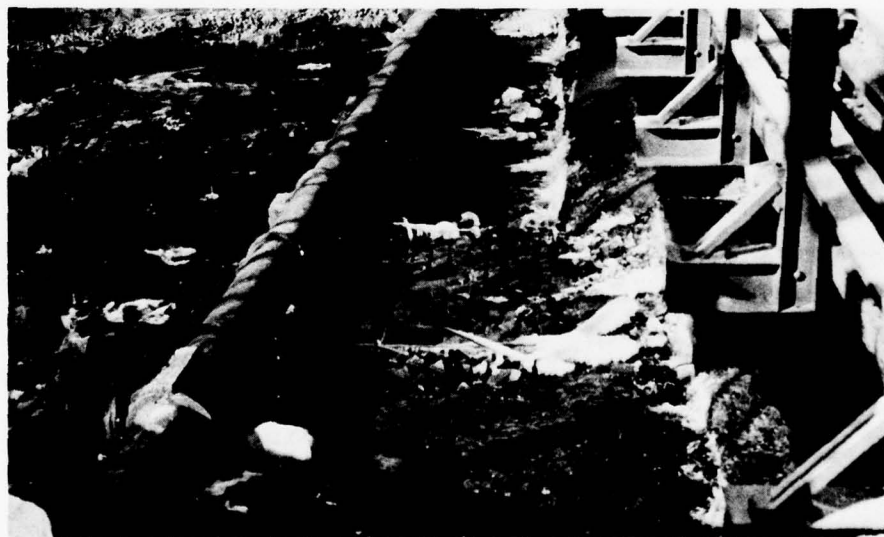
DOWNSTREAM END OF SPILLWAY LOOKING WEST

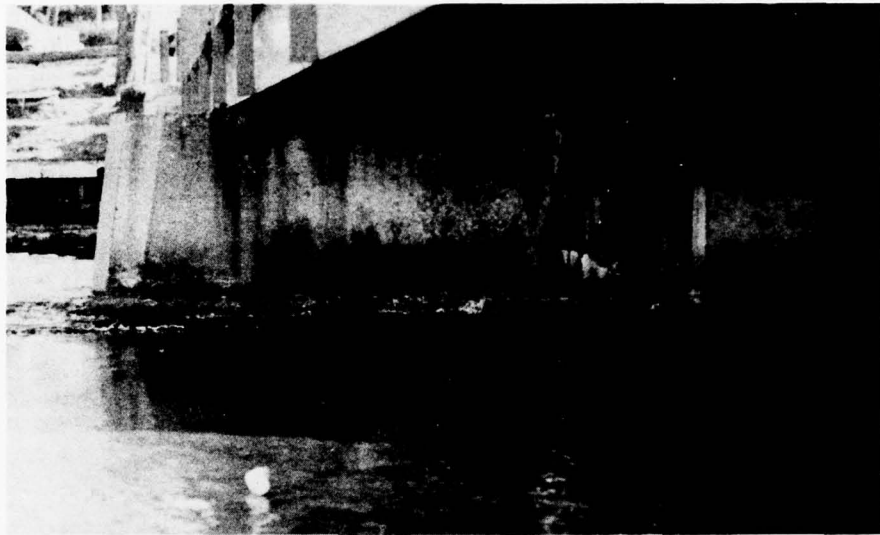
Cracks in the concrete bridge piers as well as erosion of the piers were noted during the inspection. Failure of the bridge could cause a blockage of the

spillway in addition to the other hazards normally associated with bridge failures.

CLOSEUP OF BRIDGE PIER IN SPILLWAY

Removal of the bridge piers and stoplog supports and replacement of the multiple span bridge with a single span would improve the capacity of the spillway and reduce the possibility of blockage by debris during a flood. Removal of the sudden constriction in the outlet channel downstream of the spillway would probably also improve the spillway capacity.

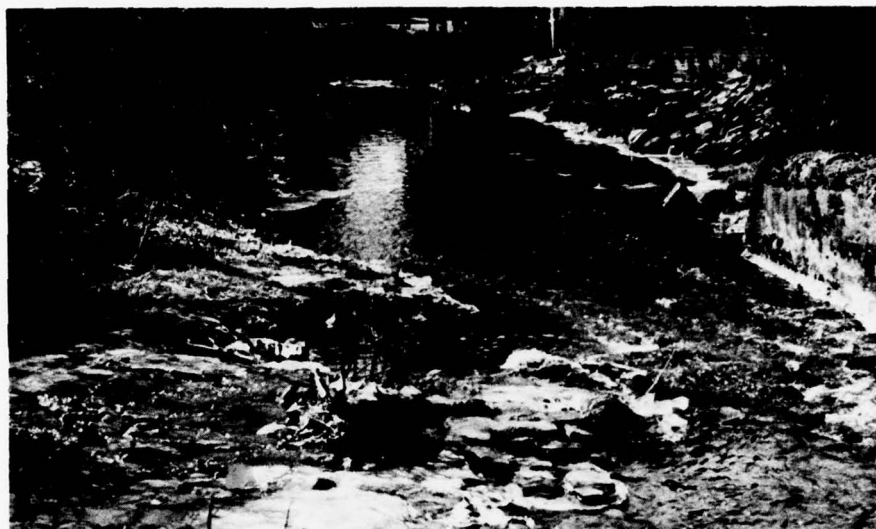
The downstream channel is a fifteen feet wide natural watercourse. No problems were noted except for the sanitary sewer & sudden constriction described under spillway section.

CHANNEL DOWNSTREAM OF SPILLWAY

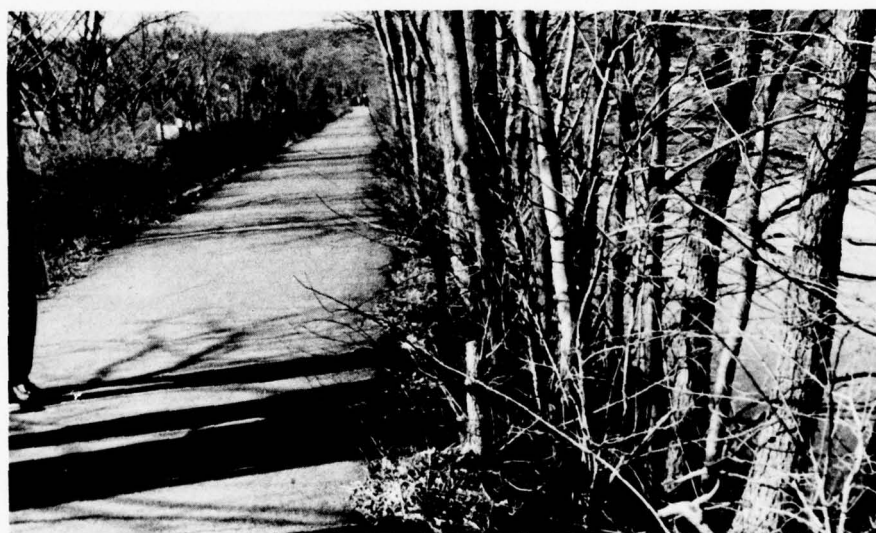
EAST END OF DAM
